Service Information Bulletin

BLACK RESIN LEAKING FROM THE OUTSIDE DOOR HANDLE(S)

B51 04 23 [SI] March 2023

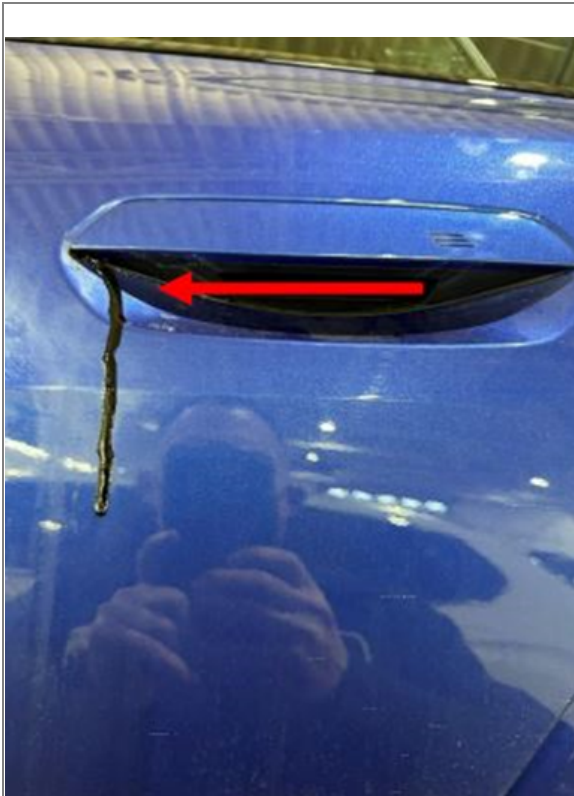
Black resin is leaking from below the outside door handle(s).

The resin has not fully cured properly on the handle and therefore can leak after installation.

Replace the affected outside door handle and clean the contamination on the door.
