Service Information Bulletin

**SERVICE ACTION: REAR WINDSHIELD**

B51 05 23 [SI] April 2023

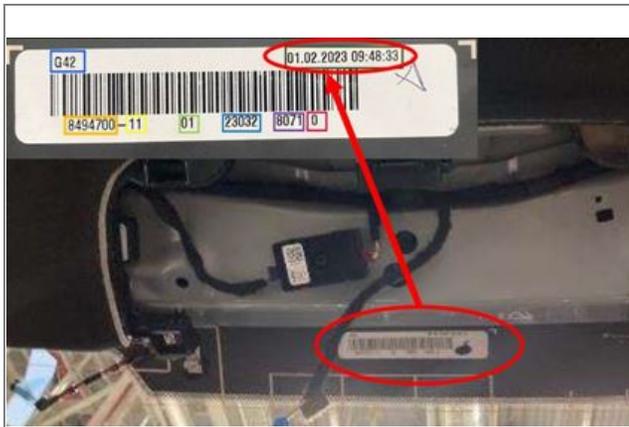
The third brake light bracket may not have been properly glued. Estimated failure rate is 45%.

- If the windshield has a production date of 01/02/2023 (Feb. 1, 2023) as shown above, the rear windshield requires replacement. Follow the repair instructions listed in AIR/ISTA (51 31 200).
- If the rear windshield has a different production date, no repair is needed, and the vehicle can be reassembled

Check the production date on the rear windshield and replace if necessary.
