CRACKING/CREAKING NOISE FROM FRONT AXLE/STEERING SYSTEM

B32 01 23 [SI] March 2023

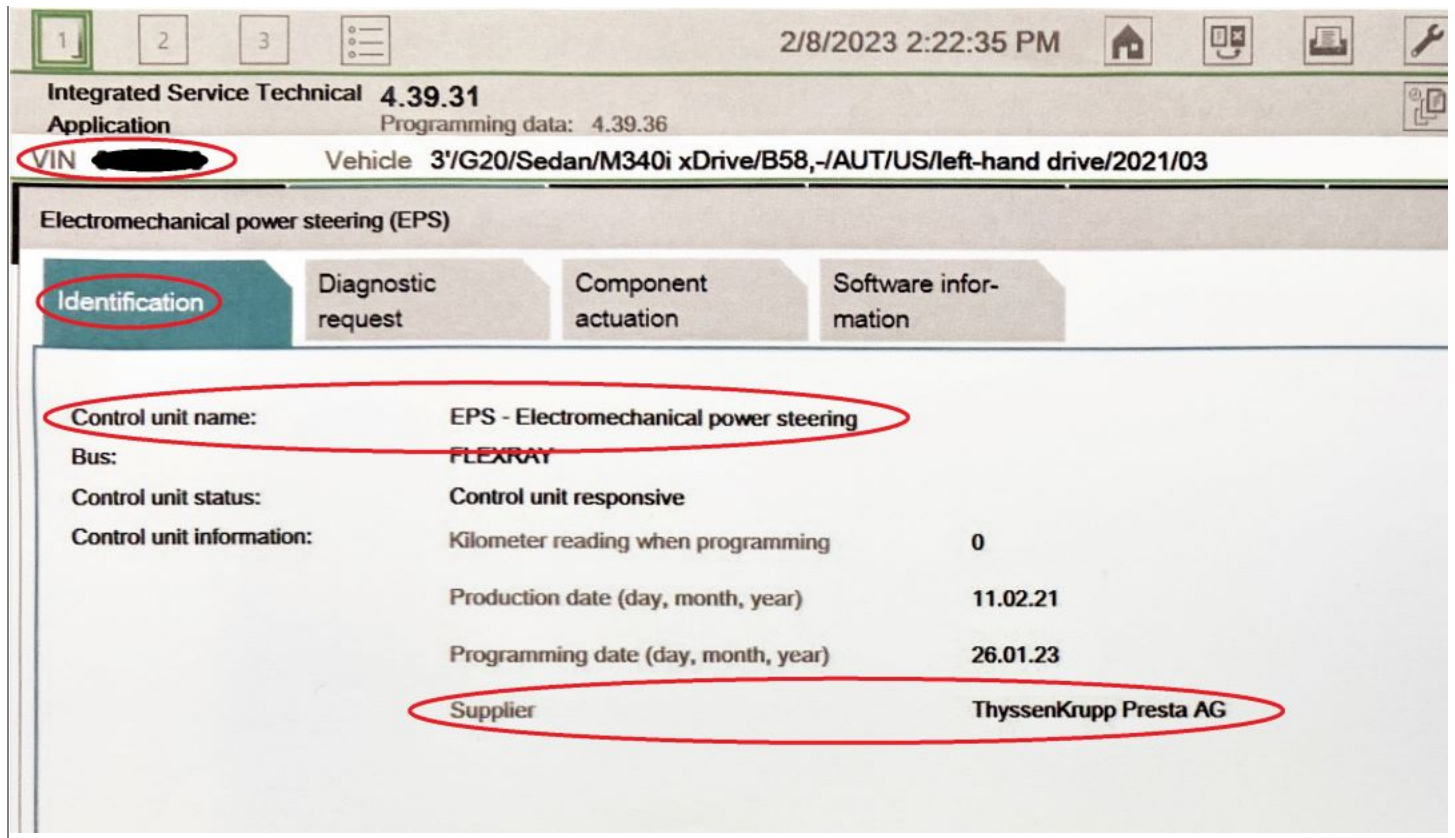
For conditions that are like the situation as heard in the videos:

2. On vehicles with the TKPS EPS, replace one or both tie rod assemblies as per REP 32 21 231.

NOTE: G20 vehicles produced up to 04/2019- always replace both tie rods (left and right).

3. Perform wheel alignment check with ride height measurement without loading the vehicle as per REP 32 00 155.
