## SERVICE ACTION: LEFT FRONT STRUT TOWER RIVETS

41 03 23 [SI] July 2023 (v01)

E-Series	Model Description	Production Date
G20	3 Series Sedan	May 23, 2023 – June 8, 2023

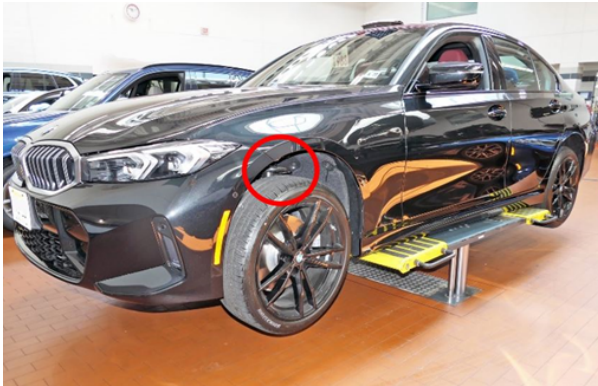
The left front suspension’s aluminum strut dome (general area circled) was incorrectly riveted to the body’s wheel-well. Overtime, corrosion can form around the rivet holes. Structural integrity would thereby NOT be reduced, because the primary strength of that dome attachment is from structural adhesive.

Cover each affected rivet head on the left front strut dome with a strong seam sealant.

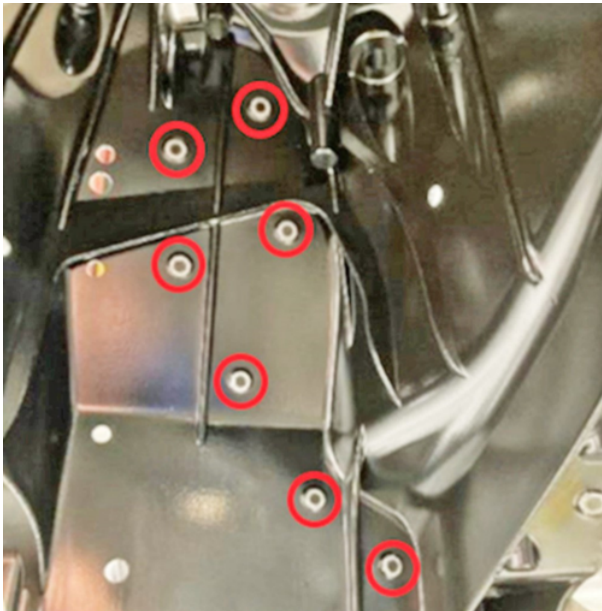
1. View of the strut dome on an unassembled body shell for clarity.

2. View of the strut dome on an assembled vehicle for clarity.
