RATTLING NOISE PERCEPTIBLE IN VEHICLE INTERIOR WITH AC ACTIVATED

64 05 21 [SI] June 2024 (v01)

This Service Information Bulletin (Revision 4) replaces SI B64 05 21 dated October 2022.

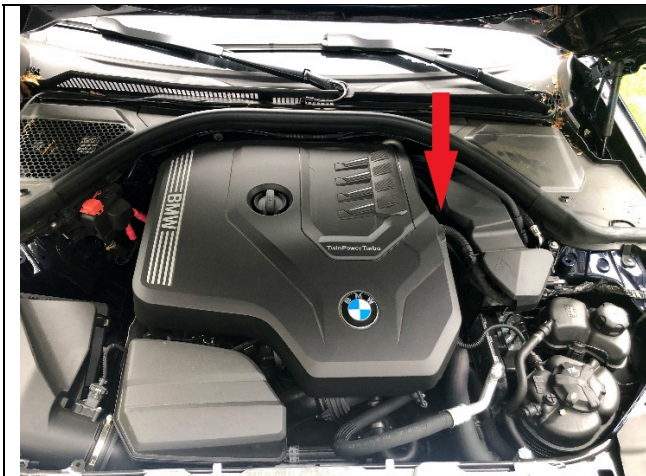
The refrigerant line double pipe and a clamp on the return line of the internal heat exchanger are in line with each other (in the direction of travel, on the left (driver) side of the engine compartment below/behind the DME) and are making contact.

The hoses are contacting here (arrow).

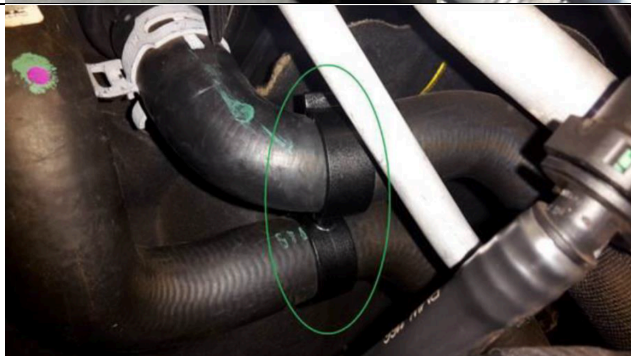
Close up view of spacer installed.
