SI B61 24 14  
General Electrical Systems

**Service Action: Install Missing CAN Terminating Resistor**

F82 (M4 Coupe)

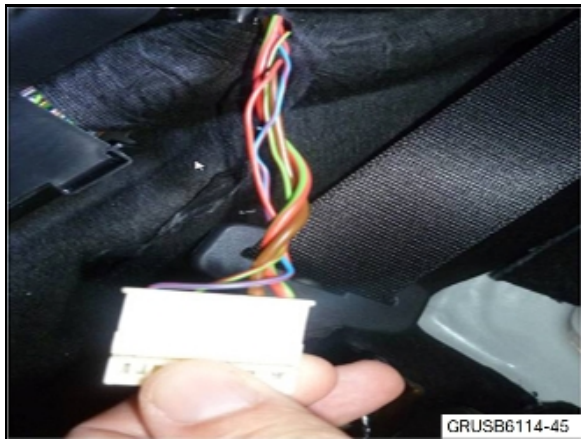
Pin 9 – Blue/Red

Pin 16 – Red

5. Expose and untwist the wiring harness and identify the two CAN wires:

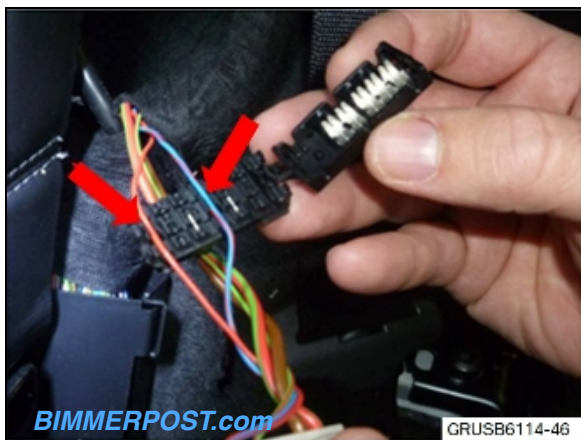
Red wire – outer groove

Blue/Red wire – middle groove

6. Guide the wires in parallel to a length of approximately 4-5 cm. Insert them into the terminating resistor connecting strip (P/N 6113 9 129 328) as shown. The two CAN wires should fit into the two grooves in the connector as shown.
