## SERVICE ACTION: LEFT FRONT STRUT TOWER RIVETS

41 03 23 [SI] July 2023 (v01)

E-Series	Model Description	Production Date
G20	3 Series Sedan	May 23, 2023 – June 8, 2023

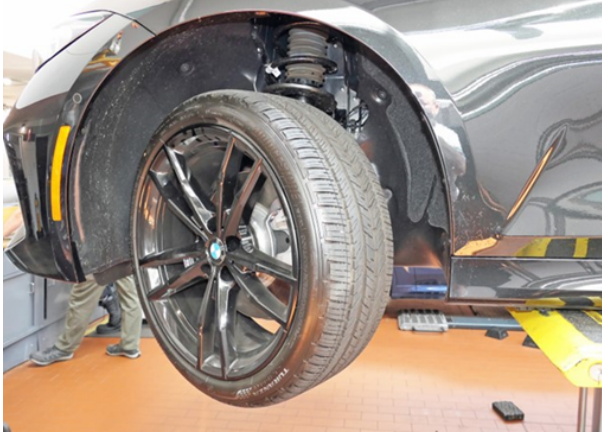
The left front suspension’s aluminum strut dome (general area circled) was incorrectly riveted to the body’s wheel-well. Overtime, corrosion can form around the rivet holes. Structural integrity would thereby NOT be reduced, because the primary strength of that dome attachment is from structural adhesive.

Cover each affected rivet head on the left front strut dome with a strong seam sealant.

1. Position the vehicle on a lift and raise it to "chest-level".

(Optional) Remove the left front wheel.

If the wheel remains on the vehicle, turn it to the right.

Note: Neither the front nor rear sections of the wheel-well liner need to be removed. The rivets are directly accessible.
